Valiant Monitoring Adds \$30k in Weekly Production

With eyes-on monitoring and proactive reporting, Valiant was able to flag a potential ESP failure before it occurred, improving production by over 80 barrels of oil per day.

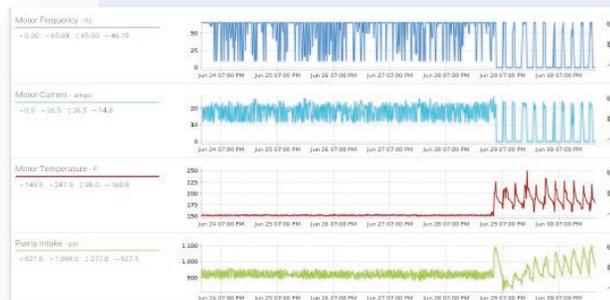
On July 1st at 9:00am, a well that showed excessive shutdowns in 48 hours was flagged by Valiant's surveillance team for a closer look. After reviewing the SCADA, increasing temperature at trips and decreasing intake pressure during shut-downs were strong signals that there was a hole in the production tubing.

SCADA screenshot of hole-in-tubing observation

Valiant immediately contacted the customer to recommend they review the ESP and consider replacing the tubing to prevent a failure.

confirmed that the operator's production setbacks were a result of the diagnosed issue and pulled the unit.

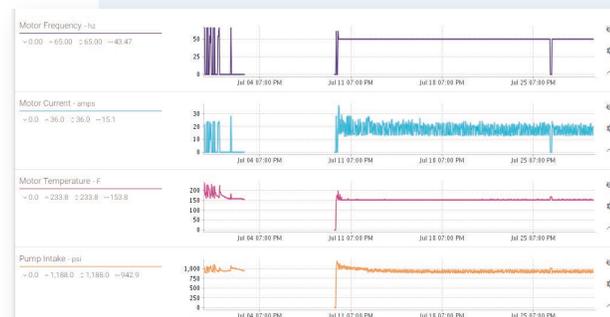
SCADA screenshot after installation with new tubing

With a quick reinstallation of Valiant's Endeavour[®] ESP and new tubing, the customer was able to ramp up production again, adding \$32,500 to their weekly production.
